# Development and Calibration of a Frangible Leg Instrumented for Compression and Bending

DSTO-TR-1829

In order to quantify the loads transferred to a human leg during a landmine explosion, the lower portion of the Frangible Surrogate Leg (FSL) was modified to incorporate a load sensor. This report describes these modifications and the work carried out to calibrate the response of the modified FSL (FSLM) to static and dynamic loads. Non-destructive drop tests were performed to characterise repeatability from test to test for a given specimen, as well as the variation of response between specimens. Upon completion of these calibrations, five FSLM specimens were subjected to the explosion of 50-gram PE4 charges buried in sand. The standoff between the specimens and the soil surface ranged from 50 mm to 200 mm. The results demonstrated how variations of the explosive input affects the load transmitted to the specimens and the resulting level of damage.

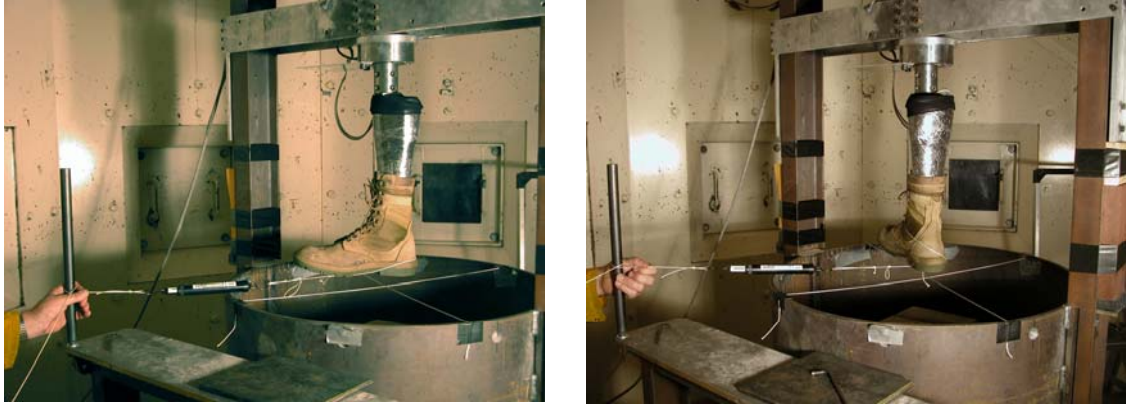
Figure 4. Technique used to apply static bending loads to the FSLM models.

around the lower end of the FSLM/boot combination and a force was applied along the horizontal plane. A simple spring balance was used to measure the applied load. Once the load was stable, the strain gauge data was recorded for a short period of time.

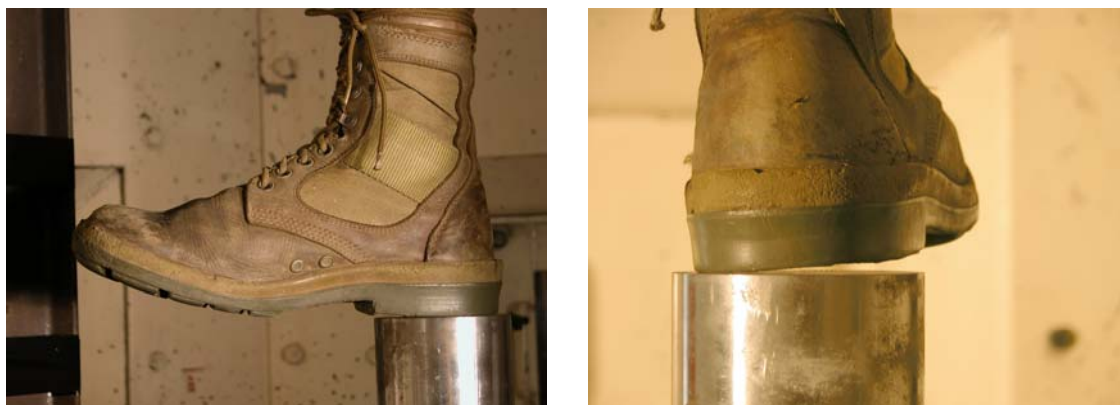
Figure 5. Position of the boot is not flat due to design of the FSLM model.

It should be noted that the FSLM construction technique yields a semi-rigid leg. When the model was mounted vertically in the test rig, the foot did not rest flat on the ground, as shown in Figure 5. The toes were slightly elevated, which corresponded to the heel-strike phase of walking. It is also important to note that the heel was not fully parallel to the ground in the lateral direction either. These offsets of the contact point relative to the long axis of the leg, and the fact that the bones of the leg are not truly vertical, meant that each drop automatically produced a bending moment.

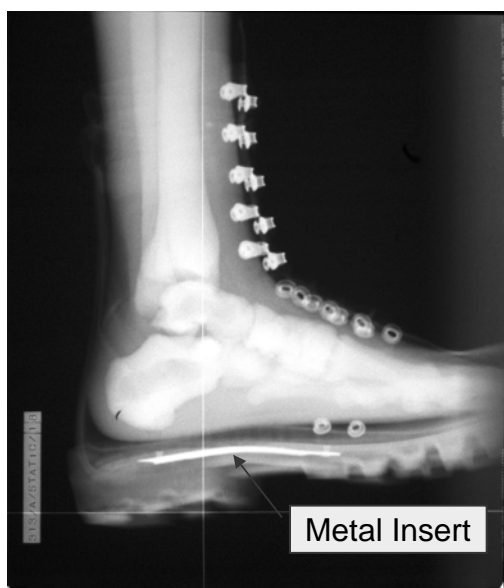
Figure 7. The motion of the metal insert in the sole of the boot was analysed.

The flash radiographs were analysed to determine the motion of a steel insert (see Figure 7) within the sole of the footwear and to assess the progression of bone damage in the leg model. However, because the FSLM is a non-symmetric three-dimensional

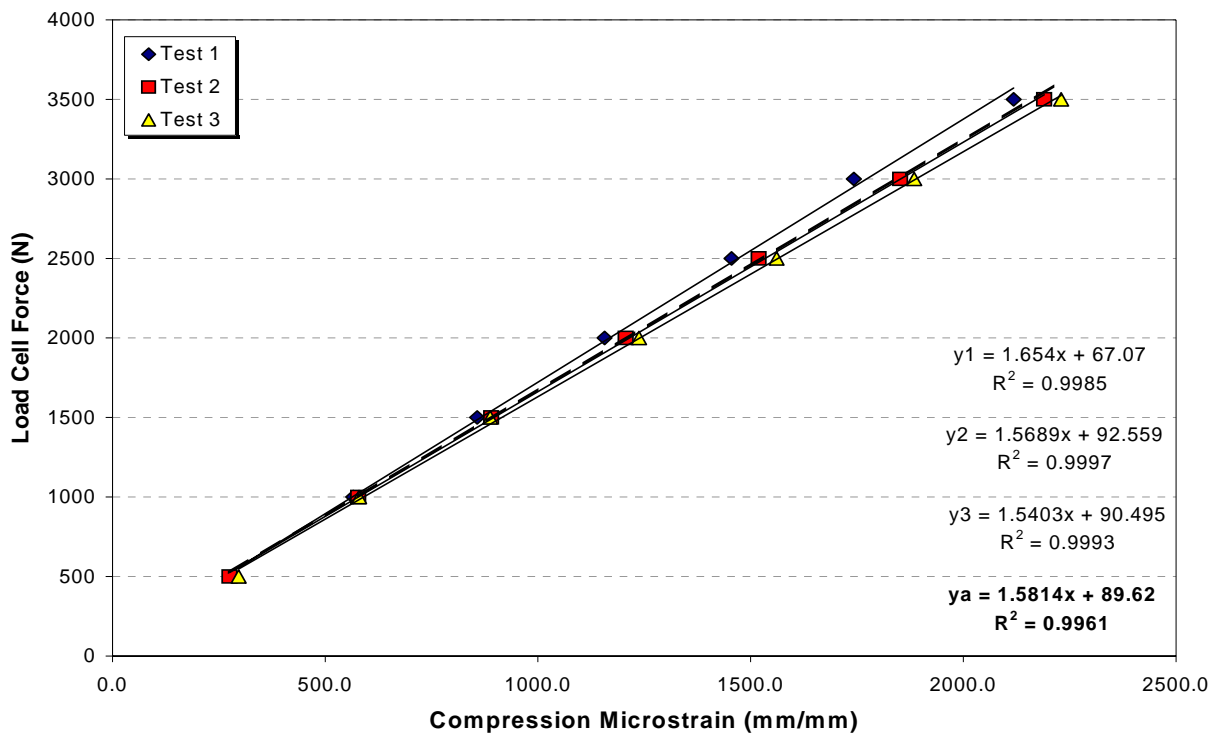
Figure 10. Typical dataset used to derive the calibration equations for compression force.

Annex C presents the results for all drop tests carried out with the five FSLM models. *Figure 10* shows the results for FSLM#1, channel C1FBA, for three consecutive drops. For this low load regime, the linearity of the data for individual drops was very good, as indicated by the goodness of fit ( $R^2$ ) values that ranged from 0.9955 to 0.9998 for all tests with all the models. The example below shows that the slope and offset varied from one drop to the next. The slope of the linear curve fits ranged from 1.540 to 1.654 Newton/microstrain, representing a 7.2% variation relative to the average slope, 1.581 Newton/microstrain. It should be noted that the results for FSLM#1 displayed the worst variation of the five legs. The best results were obtained for FSLM#4 with the three tests producing slopes that were within 1% of the average, thus showing excellent repeatability from test to test.

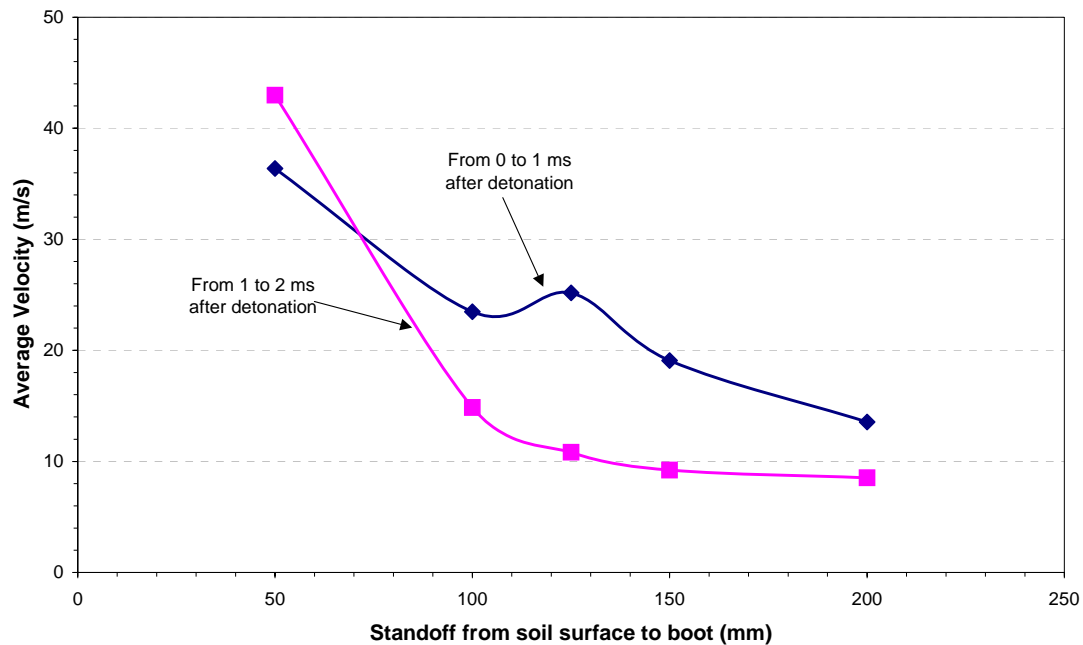
Figure 13. Average velocity of the steel insert for the 1<sup>st</sup> and 2<sup>nd</sup> millisecond versus standoff.

The average velocity of the insert was approximated from the displacement data. Since the mid-point position varied from one x-ray to the next, it was decided to fit a straight-line segment between the end points and use the displacement of the centre for each case. An average velocity was then computed by dividing this centre point displacement by the time. Figure 13 shows a plot of the results. In all cases, except for the 50 mm standoff, the centre point velocity is higher during the first millisecond after detonation. The different behaviour observed for the 50 mm case reflects the change in the damage mechanism when the front of the foot was severed. From the data, it is seen that the velocity decreased steadily as standoff was increased, suggesting (as expected) that it would have reached zero when the standoff would have become very large.

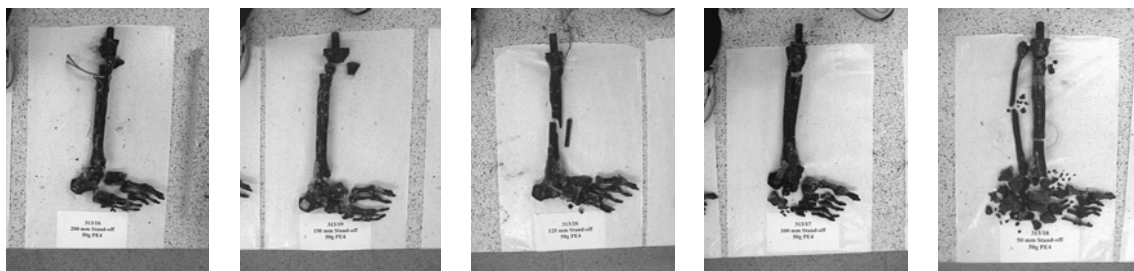
Figure 14. Increasing damage to the FSLM bones with decreasing standoff, as seen from the size and number of fragments above; standoff from left to right: 200, 150, 125, 100, and 50 mm.

The physical damage to the FSLM specimens was examined in three stages. First, an examination was carried out immediately after the test and recorded with digital photography. Gelatine was partially removed during this stage to provide better access to the bones. The second stage was an off-site examination performed by the staff of Anatomical Surrogate Technologies Pty Ltd. For the third stage, the gelatine was removed completely from the specimens and the remaining bones were photographed to provide a visual record of the level of damage as a function of standoff. This photographic record is shown in Figure 14 while Annex D provides a description.

The effect of standoff could easily be quantified from the severity of bone fractures to the calcaneus, talus, bones of the mid-foot, and the long bones. For a 200 mm standoff, the calcaneus, talus and fibula bones were intact. There was a proximal fracture of the tibia near its attachment point to the test rig, but it was assessed that this fracture was an artefact of the test model, as it did not correlate with results from tests against cadavers that were performed in the United States [5]. Although the damage to most bones was minimal, the bones of the mid-foot suffered multiple dislocations and a limited number of fractures. This is attributed to the large surface area that the foot presents to the mine blast flow ahead of the long bones. The push of the flow on the calcaneus and talus is resisted by the long bones, but there is nothing to resist the force on the bones of the mid-foot, which underwent large deformation leading to the damage that was observed. It should be noted that the bones of the mid-foot were damaged during each test, but the severity and number of fractures increased as the standoff distance was reduced.

As the standoff distance was gradually reduced, the severity of the bone fracture patterns increased. This was particularly noticeable with the calcaneus, which suffered no damage at 200 mm and 150 mm, and exhibited a single fracture at 125 mm. At 100 mm, there were multiple fractures that produced several large fragments. At 50 mm, the calcaneus fractured into a significantly greater number of smaller fragments.

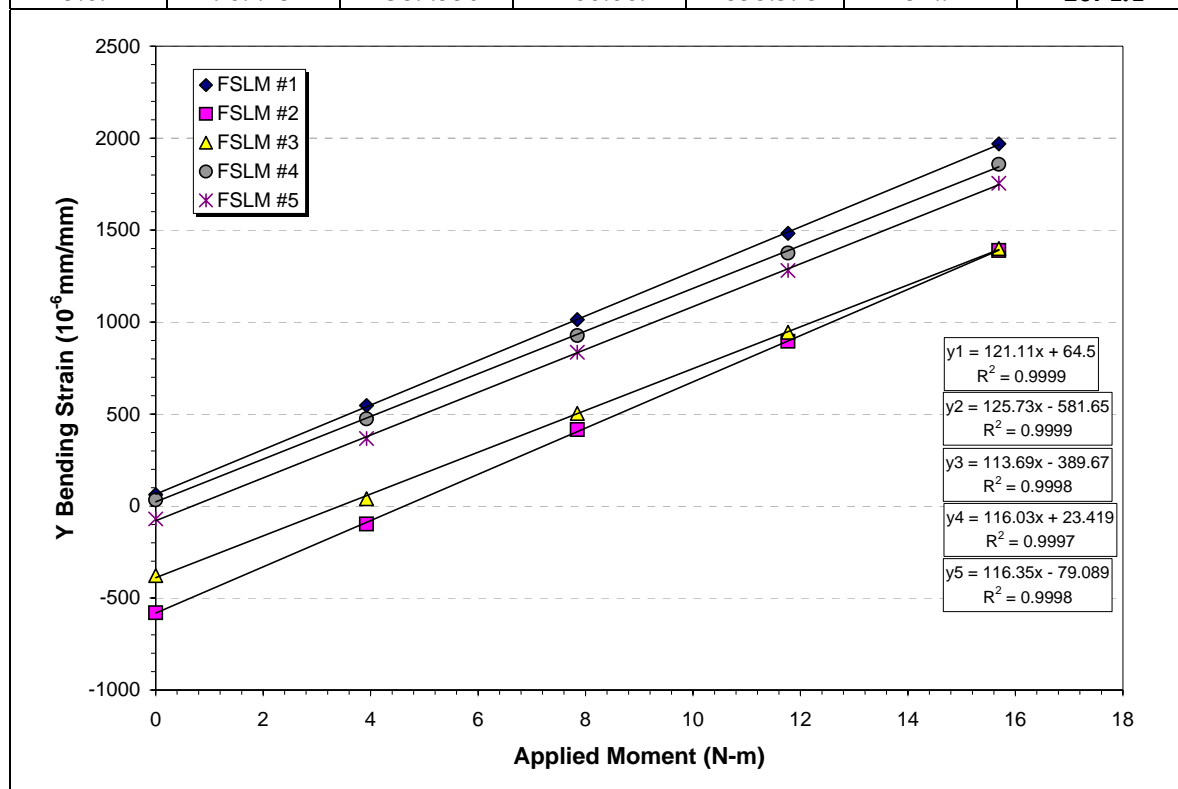
Again, the use of individual strain gauges led to wide variations in offset, but the slopes appear similar. Applying a baseline correction to the data, as if the strain gauges had been wired in a bridge configuration and zeroed before a test, produced the results listed and plotted in the following table.

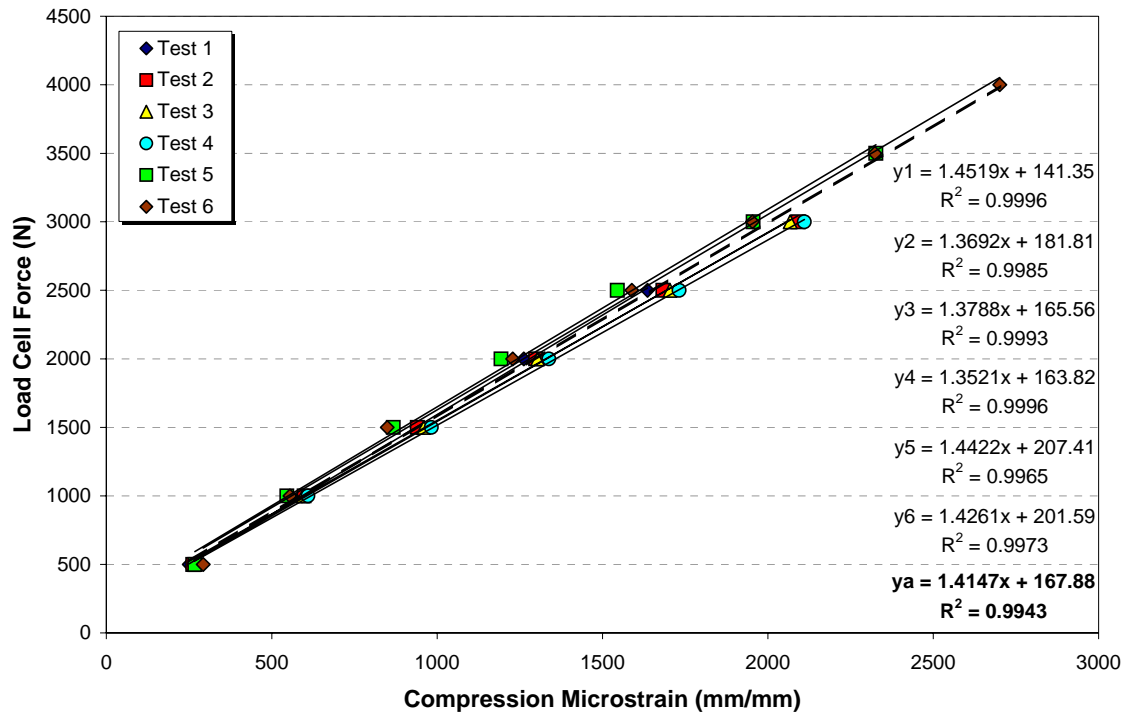
*Compression strain calibration derived from the Front and Back gauges, C1FBA, for leg 2.*

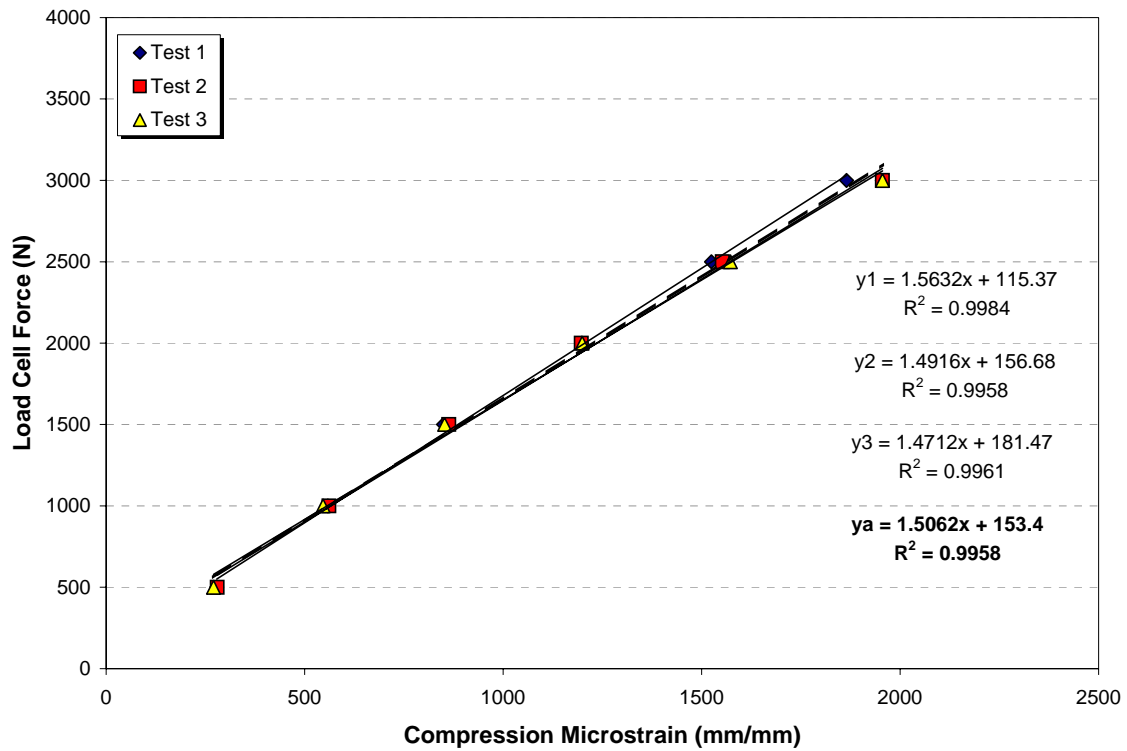
*Compression strain calibration derived from the Front and Back gauges, C1FBA, for leg 5.*

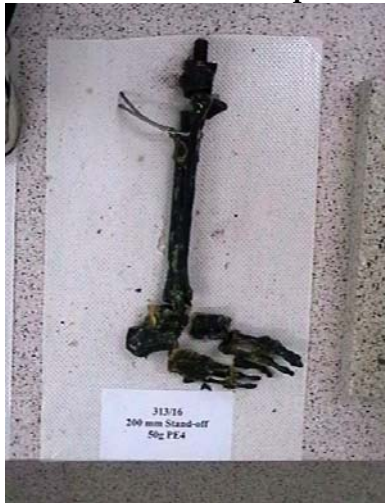
The gelatine was stripped from the FSLM to expose multiple fractures to the metatarsal and tarsal bones, including a fracture forward of the talus. The calcaneus was not fractured and the talus had not been crushed. The fibula was intact while the tibia was broken at its proximal end, near the end of the metal pin insertion. This break does not correlate with the results from similar experiments with cadavers [5]. It is therefore considered to be an artefact of the mounting method used to attach the leg to the test fixture and would likely not occur in a real life accident.

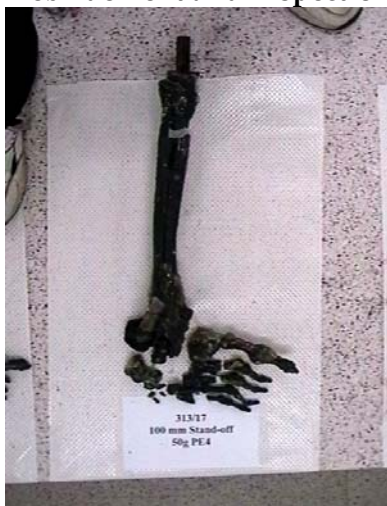
Upon removal of the gelatine from the FSLM, the fibula was found to be intact. The tibia had a transverse fracture immediately above the level of the built-in load cell. There were no apparent fractures to the distal end of the tibia and fibula. The metatarsals and tarsals suffered multiple fractures and dislocations. There were multiple fractures of the calcaneus, which had been sheared about a vertical plane through the middle of the bone.

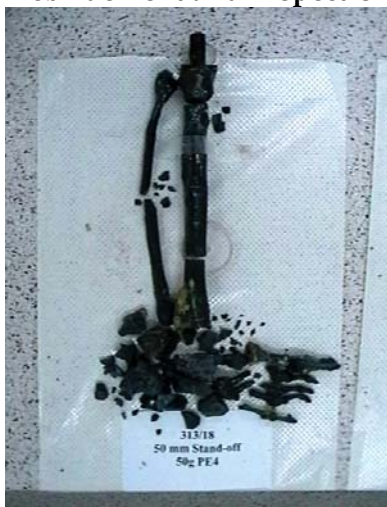
Debridement of the gelatine from the FSLM clearly showed a mid-fibula fracture and a 1/3<sup>rd</sup> distal fracture of the tibia. The tibia also fractured at the proximal end through the metal pin attachment, an artefact of the mounting technique. All foot bones, with exception of the phalanges, suffered extensive comminution. These bones were avulsed during the traumatic amputation process. Soot and dust coated the bone fragments that had been recovered from the blast chamber as well as the distal end of the long bones. The calcaneus and talus were shattered into numerous small pieces.

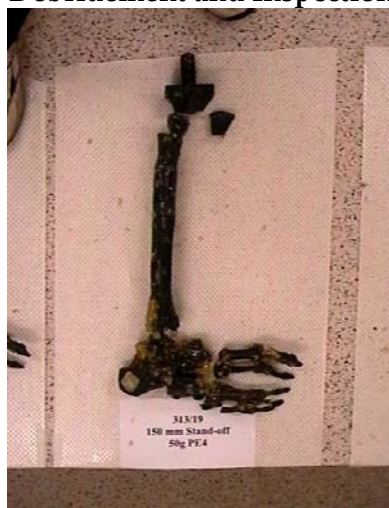
Upon debridement of the gelatine from the FSLM, the fibula was found to be intact. The tibia had a transverse fracture above the level of the built-in load cell. There were no apparent fractures to the distal end of the tibia and fibula although there was a dislocation of the talus from the long bones. The metatarsals and tarsals suffered limited fractures and dislocations. There were no fractures of the calcaneus and talus. The bone group of the mid-foot (sub-talar group) suffered multiple dislocations.

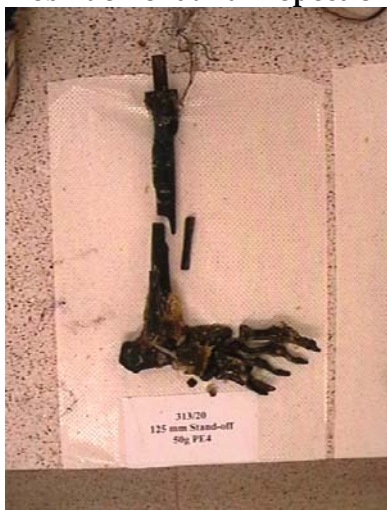
Debridement of the gelatine from the FSLM revealed multiple fractures to the metatarsals, tarsals, and to the proximal phalanges. There was single vertical fracture across the calcaneus in its mid-plane. The talus was intact and remained attached to the tibia. The tibia had a mid-shaft fracture. The fibula suffered a combination of mid-shaft and 1/3<sup>rd</sup> distal fractures, one being with a classic fragment.
